October 25, 2005  
Project No. 20-0539

## STRUCTURAL OBSERVATION

RE: Structural observation of Grainger Building, Reedley, California.

Location: 1801 10<sup>th</sup> Street  
Reedley, CA 93654

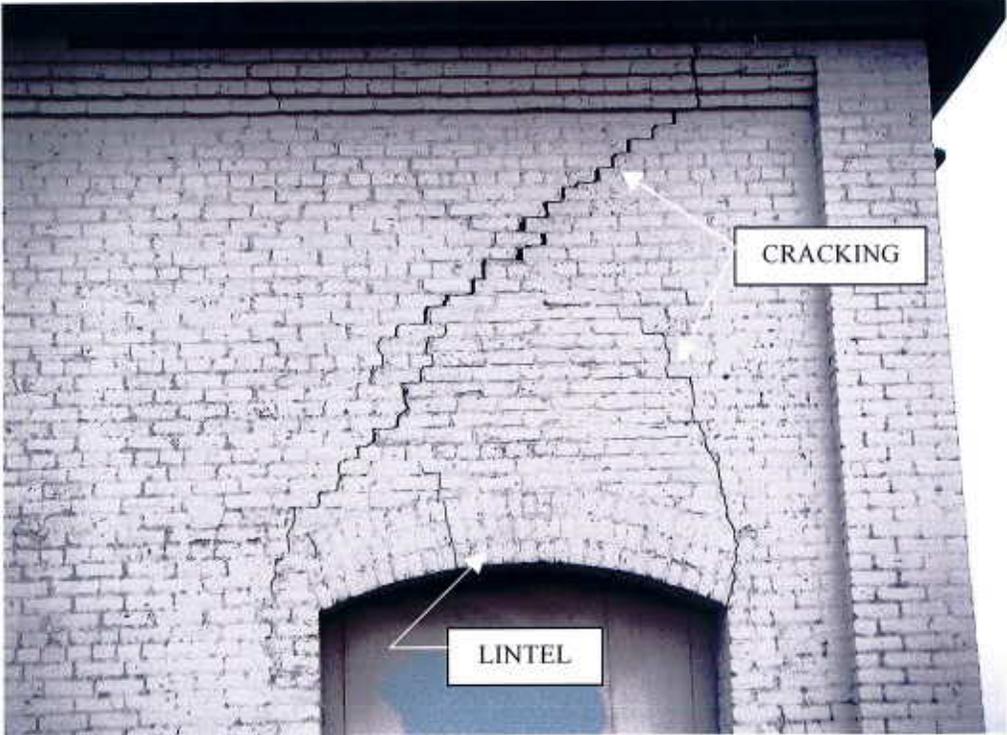
**PHOTO 1  
BUILDING EXTERIOR**

Photos 1 through 6 show the exterior of the structure. The unreinforced brick walls and pilasters are deteriorated. During the observation this manifested itself in two different ways. First the mortar joints and bricks would crumble if rubbed. Second, as seen in the attached photographs, the unreinforced brick walls and pilasters have cracks. These cracks are most prevalent at the brick pilasters, that support the roof trusses, and at the brick wall that spans openings in the wall, known as lintels. These areas are portions of the wall that higher stresses occur due to vertical loads.

In conclusion because of the deteriorated state of the unreinforced brick walls the structure is deemed to be unsafe.

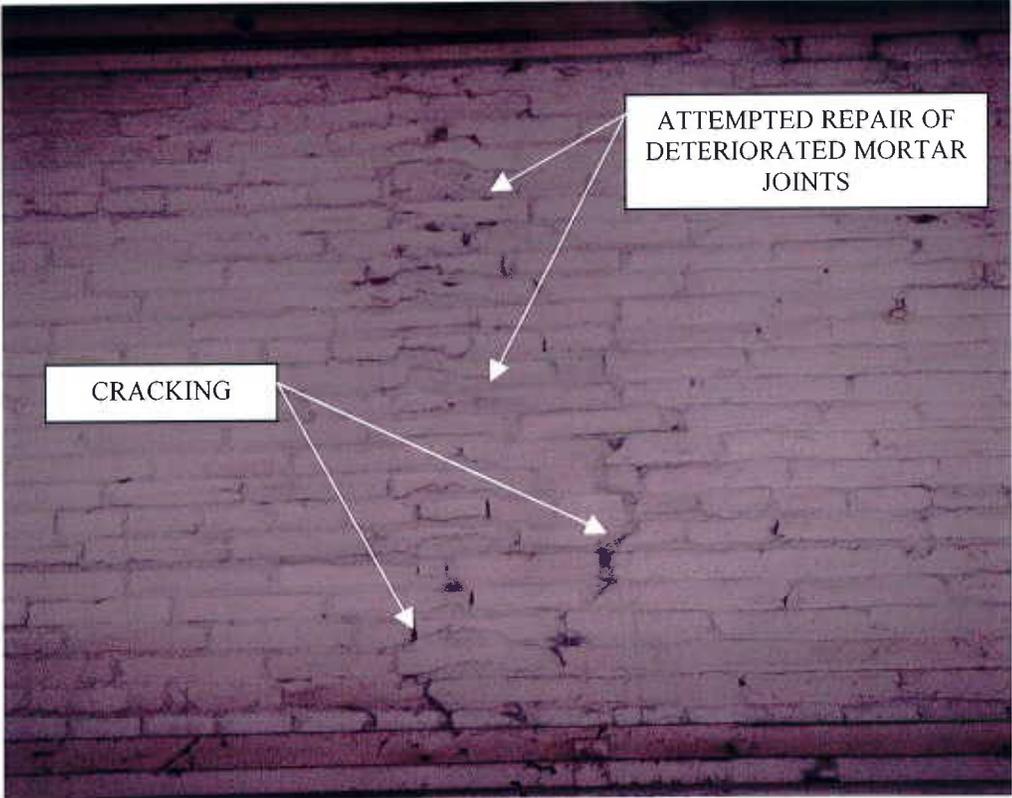
PHOTO 7  
BUILDING INTERIOR

Photos 7 through 9 show the interior of the structure. These photographs show that the cracks in the unreinforced brick walls and pilasters occur throughout the entire width of the wall. The wood trusses were also observed. They seem to be in good condition although the observation for them was done from the ground in a poorly lighted building.
